# BAWG

# 2022

## FIELD & ACTIVITY REPORT

Belfast Area Watershed Group

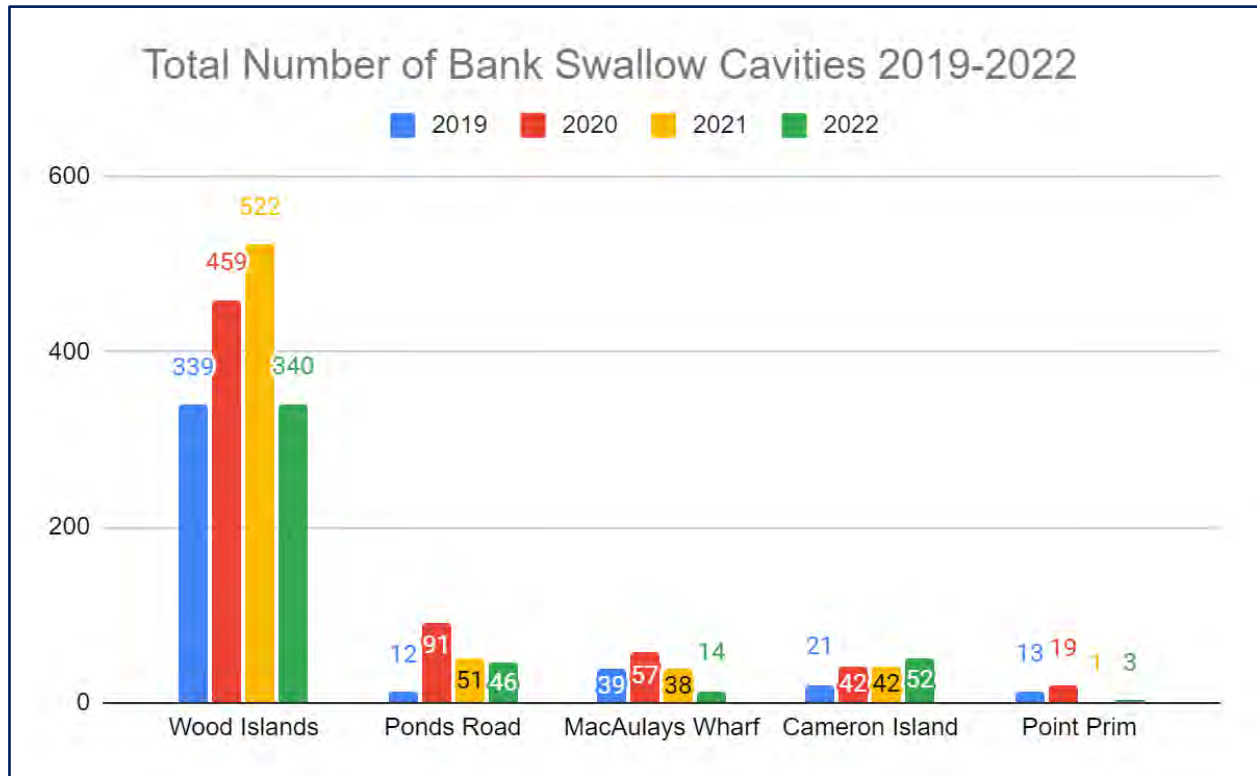
Figure 1 Includes active and non-active cavities.

Our results show that the Wood Islands colonies are still the most numerous in the watershed, with 340 total cavities found. This location was showing an annual increase in nesting cavities until this year (2022). The Ponds Road colonies experienced an increase in nesting cavities during 2020 but has been experiencing a decline in the years since. Similarly, the MacAulay's Wharf population had an increase in nesting cavities in 2020 and a decrease in the years following. The Cameron Island colonies have experienced an increase in the number of nesting cavities since 2019. The Point Prim population had a slight increase in nesting cavities this year where it went from 1 nesting cavity in 2021 to 3 nesting cavities in 2022.

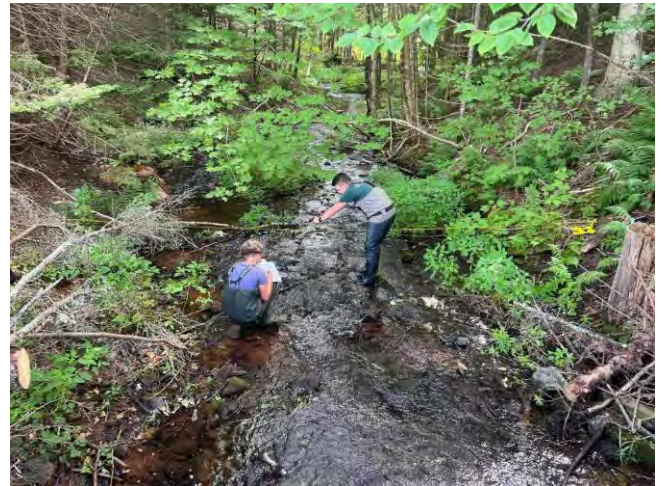
*Taking depth measurements for the RGA*

BAWG began conducting rapid **geomorphic assessments\*** (RGA's) this past August. We were able to complete a section of river along the MacLeod Road system (end of the **estuary\*** upstream to the first pond). We found that this section of stream was mainly in a state of **aggradation\***. RGA's are used to help understand what our streams are trying to do. This helps us decide what (if any) stream enhancement work needs to be done.

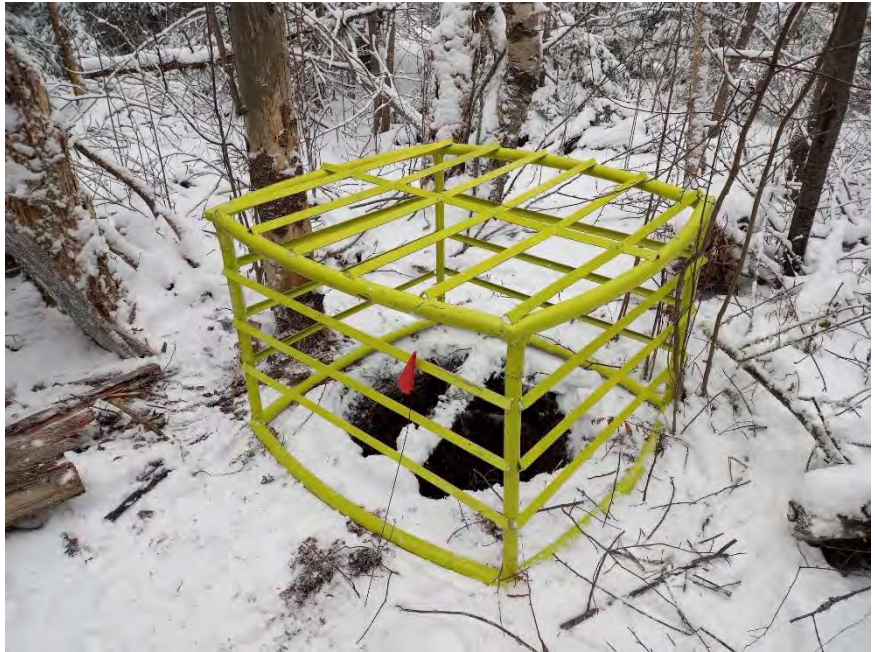
*In progress installation of protective cage at bat monitoring station*

In late fall, a protective frame was installed over an abandoned well site which has been part of our acoustic bat monitoring program for three years. This bat hibernacula is a shelter occupied during the winter. Funding from the PEI Wildlife Conservation fund was critical to protecting this area.

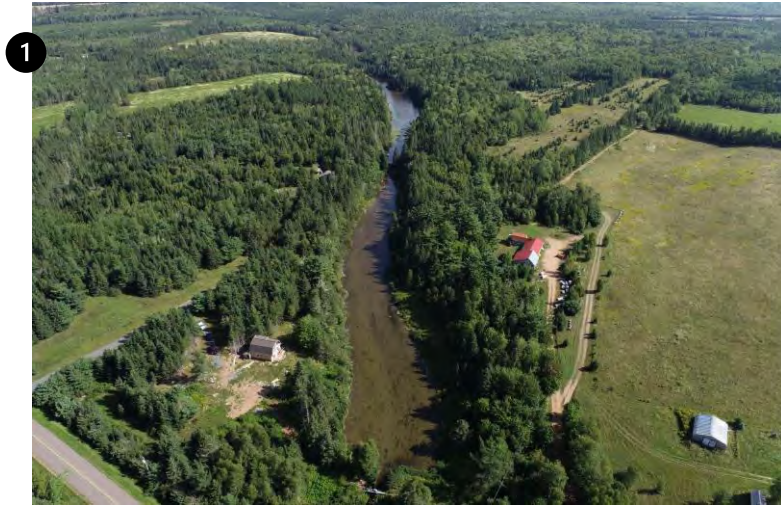
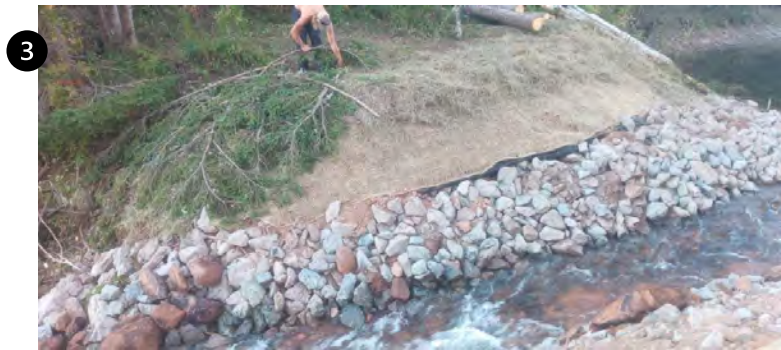
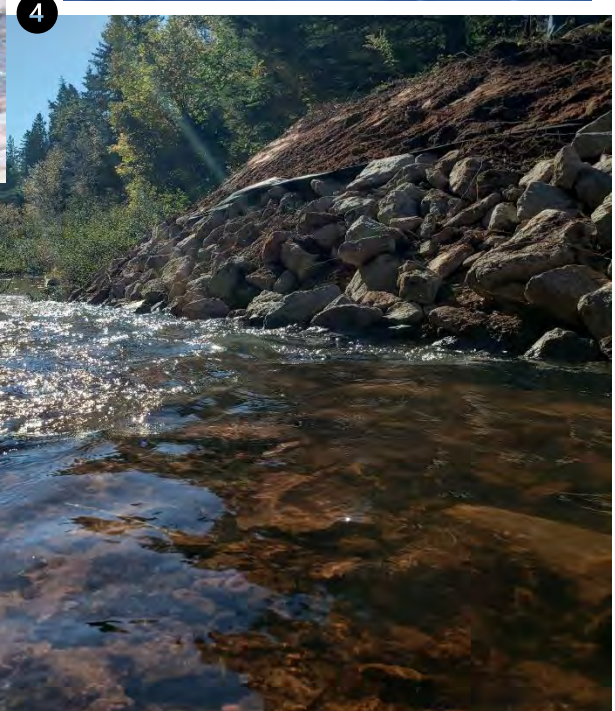
1. Drone image taken by Souris and Area Branch of the PEI Wildlife Federation (Jake MacKinnon)
2. Pre-construction debris removal
3. Post-construction bank protection
4. The new channel

In September 2022, a rehabilitation project funded by Department of Fisheries and Oceans Canada - Small Crafts Harbours (DFO-SCH) began with Phase 1. The aim is to rehabilitate degraded aquatic habitats and remove fish passage impediments. The project site is on the upstream side of Garfield and Camp Rd, Melville. These activities included the support of the PEI Watershed Alliance and PEI Forests, Fish and Wildlife. In addition, we thank our

The removal of the road and culverts will eliminate the existing head pond and the second phase of the project will include restoration of the upper reaches of the river system. The restoration work in this area will involve bank stabilization, deflectors, cross vanes, digger logs and channel blockers to develop and restore a more natural river channel and thalweg. To meet our obligations for this project, a Monitoring Report was submitted to DFO that included all our biological sampling with the aim of providing a baseline from which we will be able to monitor the project's success.

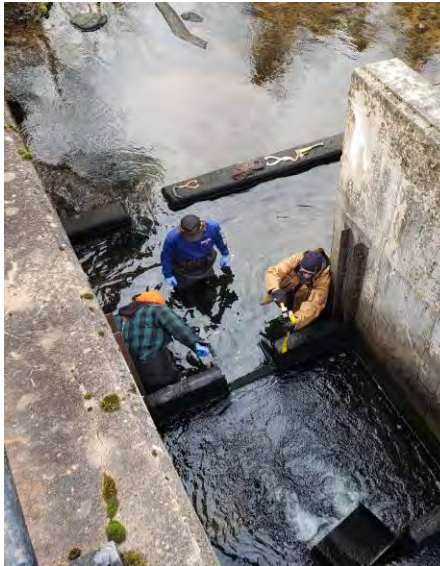
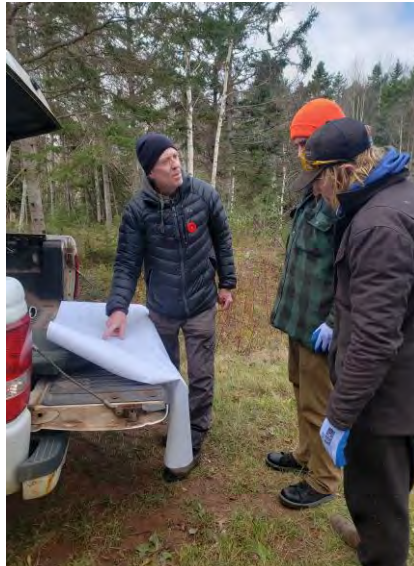
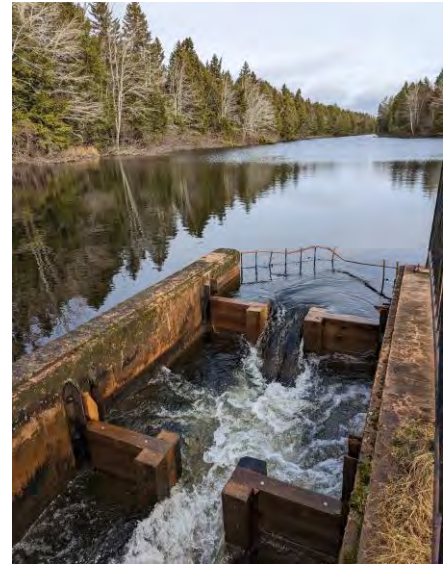
Rehabilitation at MacPherson Mill Pond (Flat River). Centre: Alan McLennan discusses the plan with BAWG fall crew – Billy Gamble, Andrew Gamble. Right: opening of newly constructed baffles

In December, our fall crew assisted the Province of PEI with the rehabilitation efforts at the fishway at the MacPherson Mill Pond (Flat River). The aim of the reconstructed weir and fish ladder baffles is to improve fish passage and improve habitat conditions. BAWG will continue with monitoring (fish counting fence) to document the success of this project, including native species planting (in spring 2023) to decrease the potential of any erosion at site.

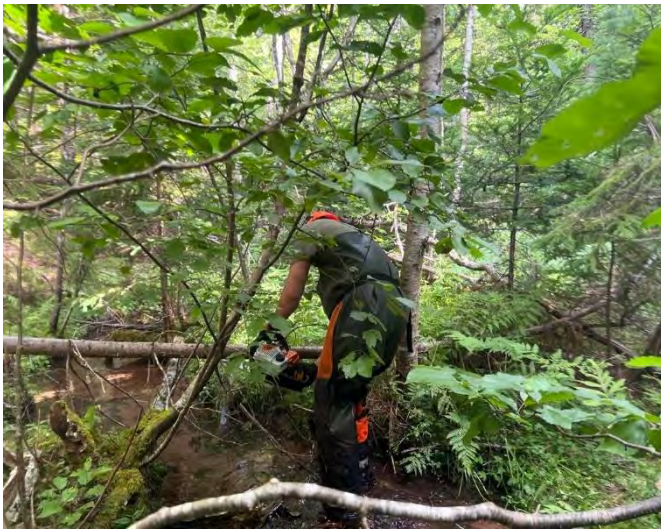
*Foraging further upstream (Flat River above Gairloch trail - Gairloch Rd.)*

The crew also foraged further upstream this year (from Gairloch Trail above Gairloch Rd. until landowner permission stopped. Approx. 850m). Major blockages were removed from above the Garfield Rd. stream crossing.

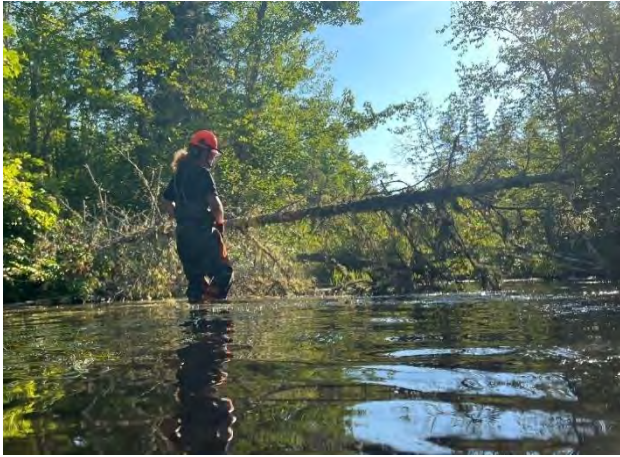
*Belle River before clearing.*

This section of the river was cleared of any main blockages. No brush mats or plantings were done on Belle River this year. We were unable to electrofishing along Belle River this season due to extensive damage from Hurricane Fiona. A habitat assessment trial was done, with the PEI Watershed Alliance, from Garfield Rd. to Munns Rd.

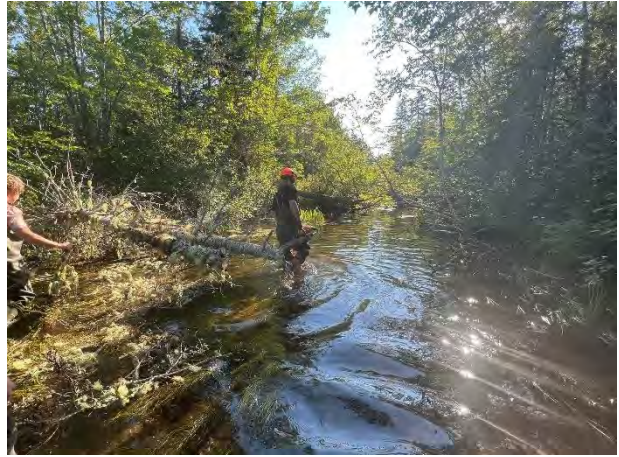
*Section of Belle River after clearing*

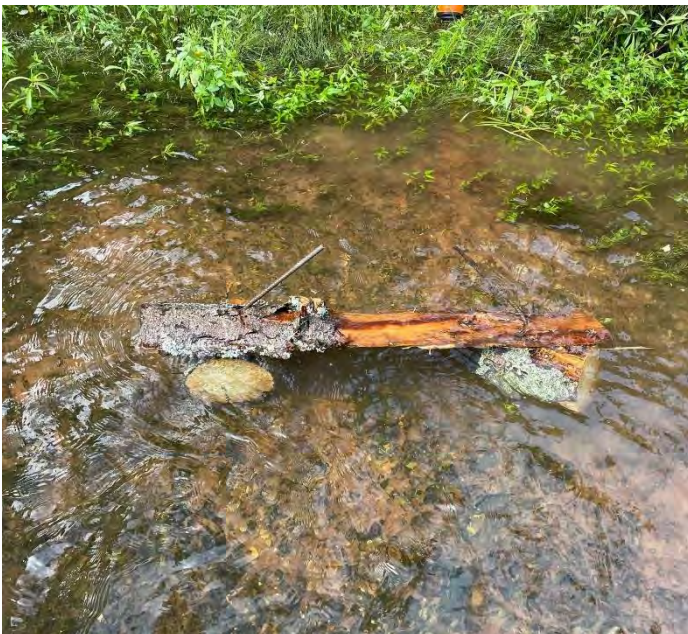
*Cover Log Roseberry Twins, Aug 2022.*

No stream assessments were completed at Roseberry twins this year. No clearing was done on Roseberry twins and no brush mats were added. No trees or shrubs were added this year. One **cover log\*** was placed below Roseberry Rd. to create additional fish cover.

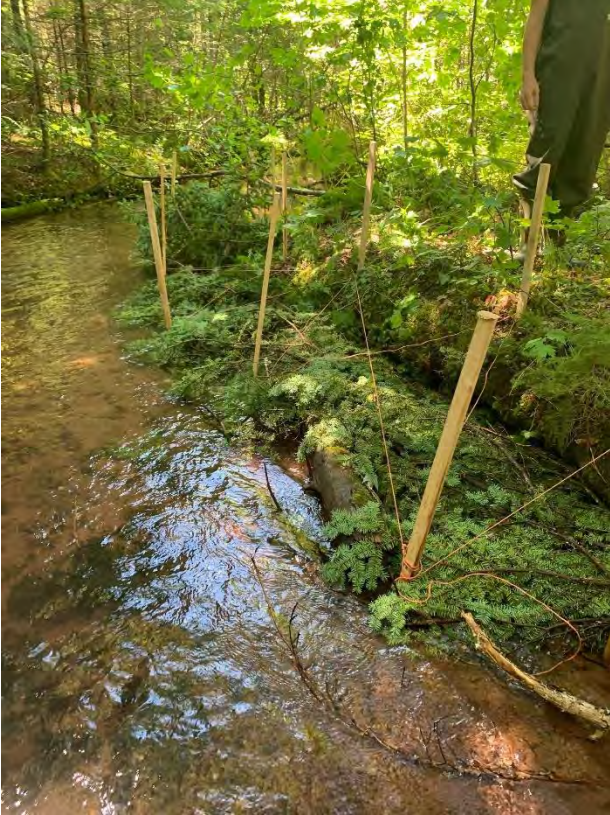
*Brush mat above Roseberry Pond, Aug 4, 2022.*

Stream assessments were conducted from Roseberry Rd. to above Garfield Rd. Major blockages were removed from this section. Two **brush mats\*** were made above Roseberry Pond, three braided stream sections were plugged with brush, and previous brush mats from 2021 were topped up. Two cover logs were also placed below Roseberry Rd. The crew rebuilt/repaired a rock weir in the **fishway\*** at Roseberry Pond. 30 shrubs were planted on the banks of Roseberry Pond Fishway (bayberry, wild rose, red-berried elder).

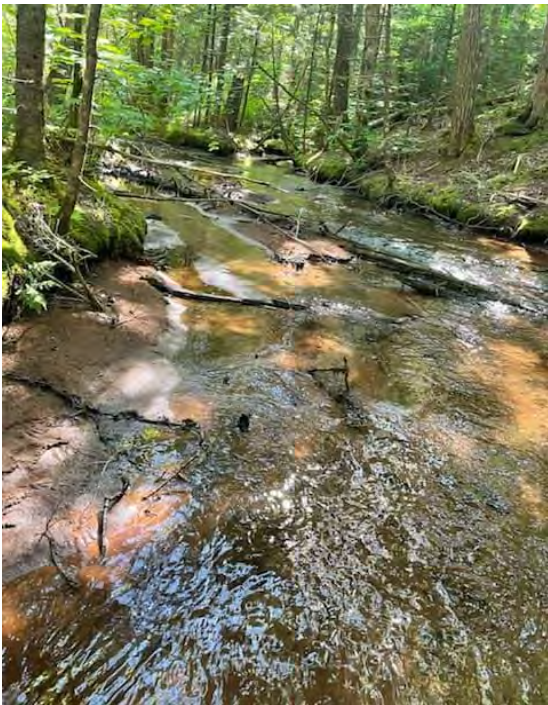
*(Before) Aug 24 brush mat*

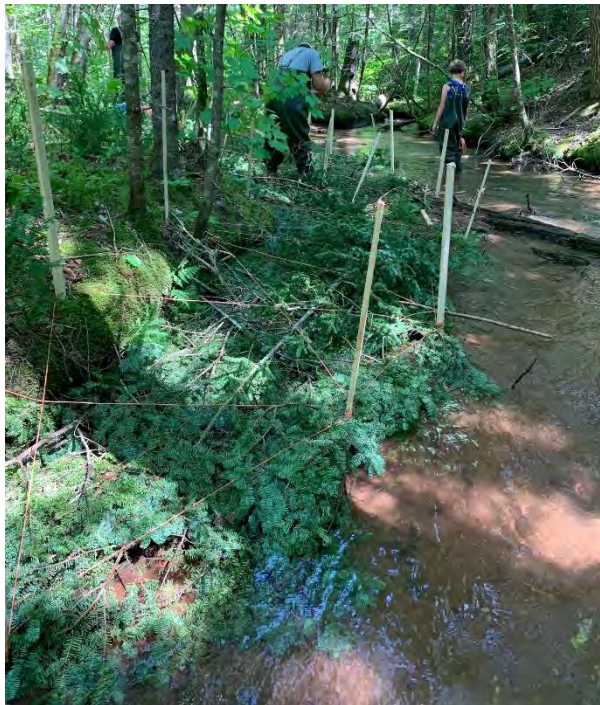
*(After) Aug 24 brush mat*

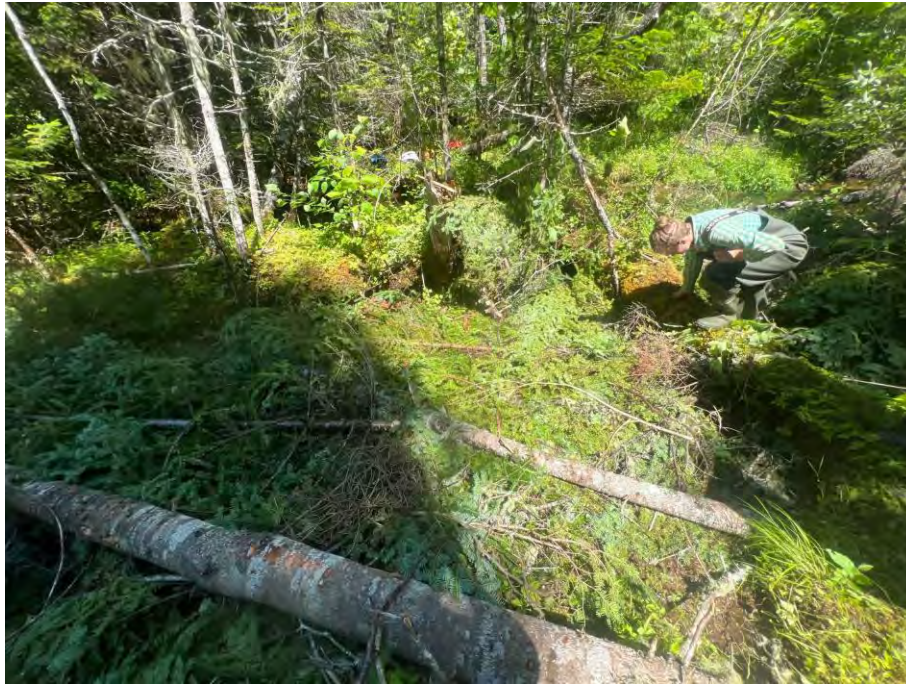
*Plugged braid above Roseberry Pond (1/3)*

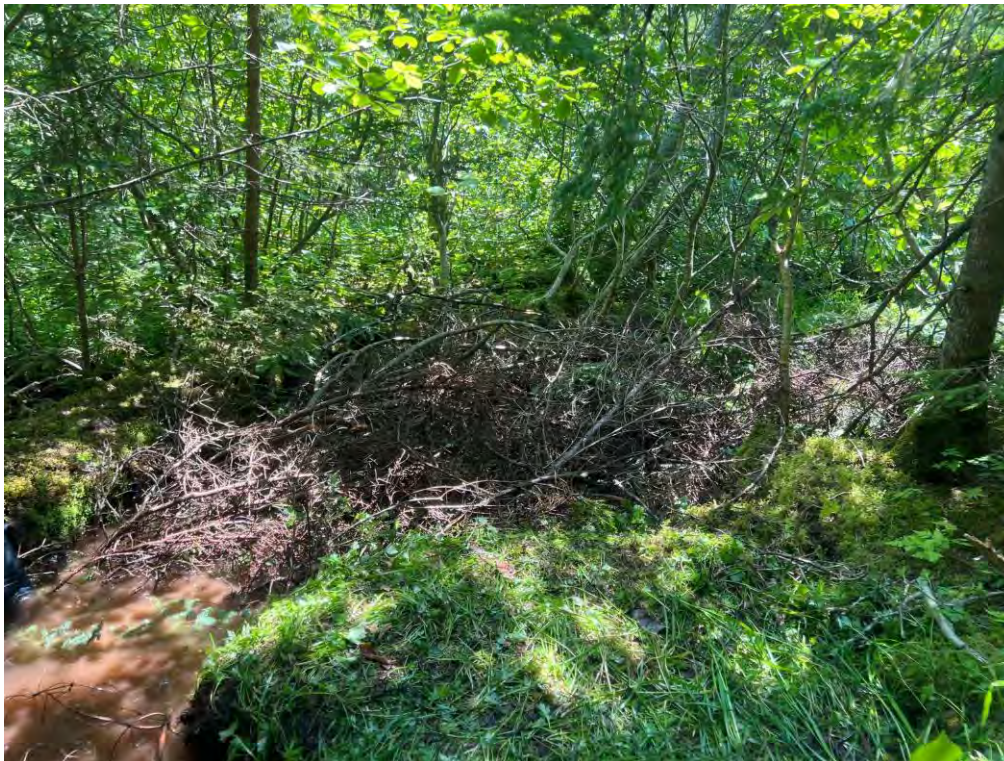
*Plugged braid above Roseberry Pond (2/3)*

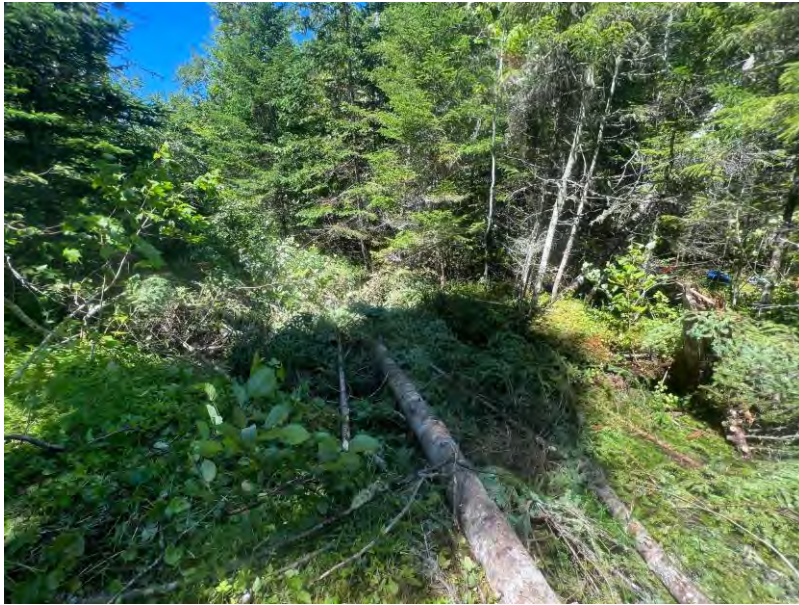
*Plugged braid above Roseberry Pond (3/3)*

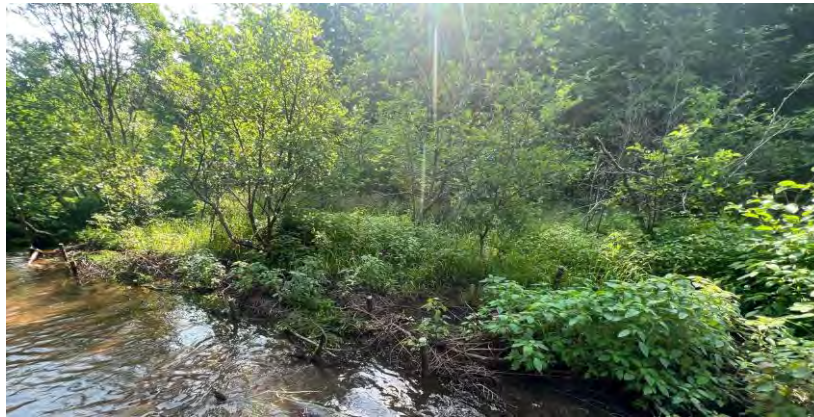
*Topped up brush mat from 2021*

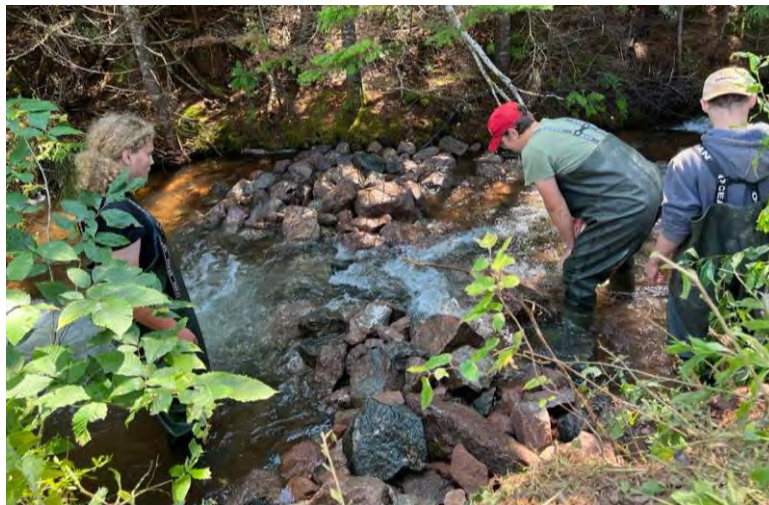
*Rock Weir at Roseberry Pond*

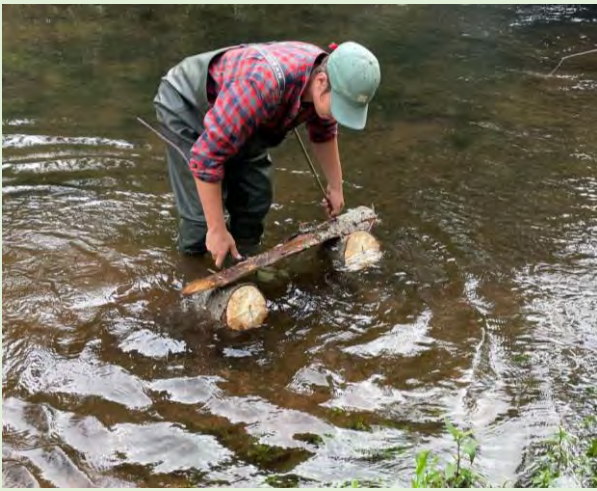
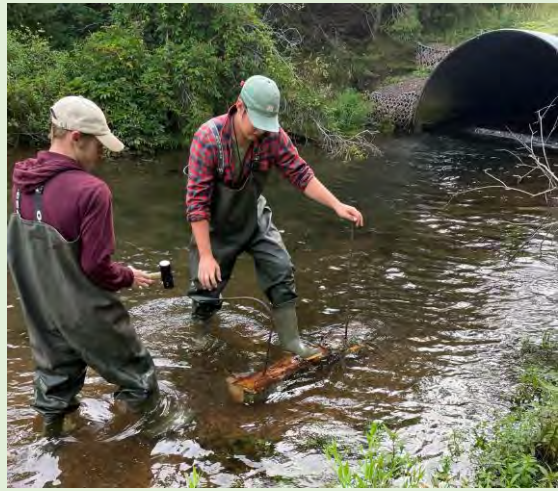
*Cover log installation – Roseberry Pond, August 2022*

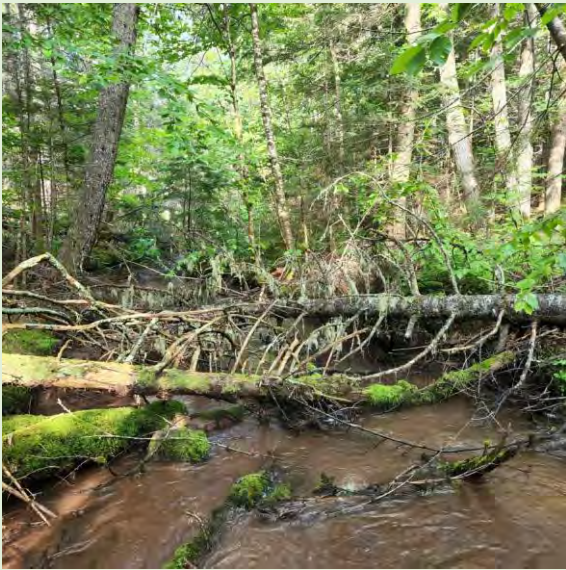
*Before clearing – Pinette River south branch*

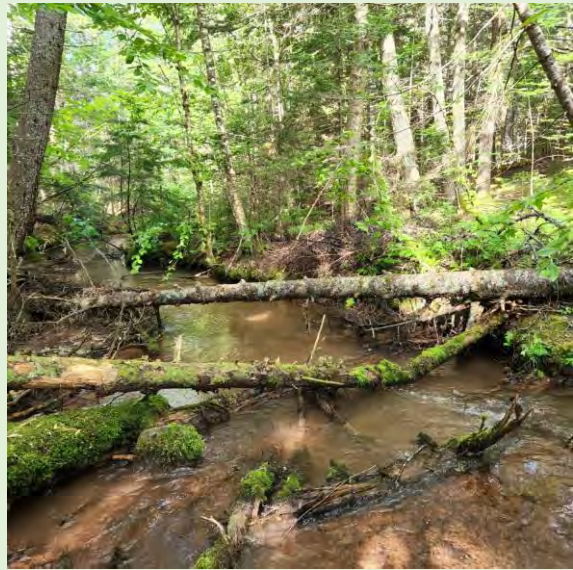
*After clearing – Pinette River south branch*

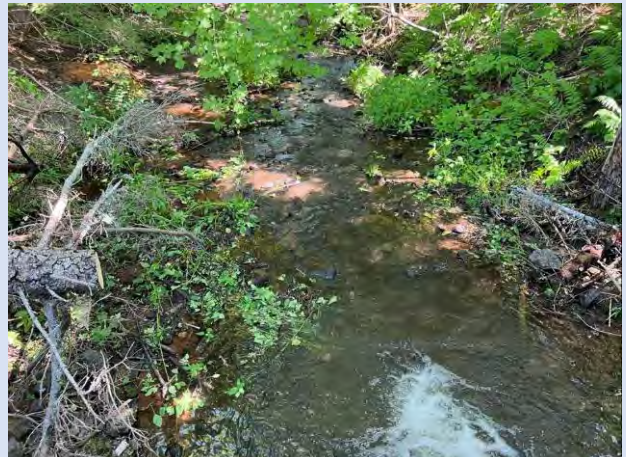
Removal of downed tree within the stream on downstream section of MacLeod Rd.

A stream assessment from the estuary to the pond above MacLeod Rd. was completed. Downed trees were removed below the culvert at MacLeod Rd. No brush mats or plantings were done along this section this year. A rapid geomorphic assessment (RGA) was completed from above the estuary to the pond above MacLeod Rd. including 5 detailed cross sections used to graph the stream bed.

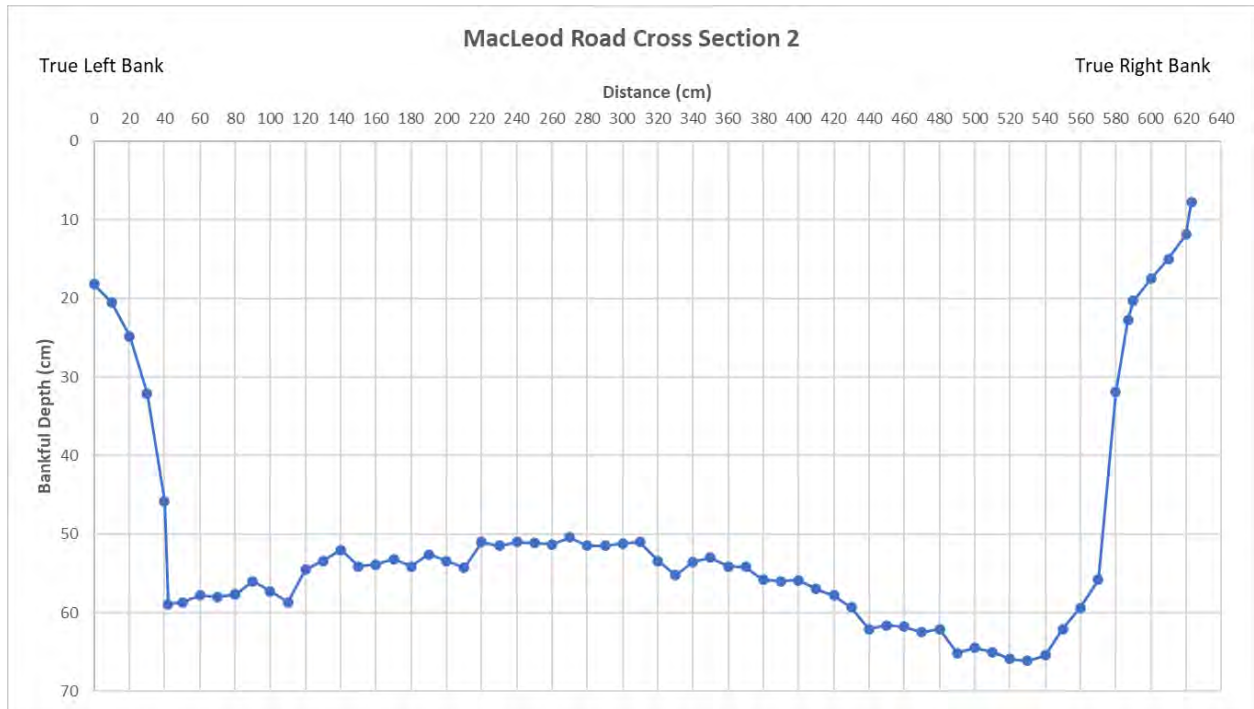
Example of a stream cross section completed. This is a visual representation of the stream bed with the left and right sides showing the stream banks. The water would flow through the middle of the graph.
